Manhole Inspection Summary

Manhole # S69U__002MH

Insp Date: **4/11/08 10:22 AM**

Location Address: **6620 Holabird Ave.**

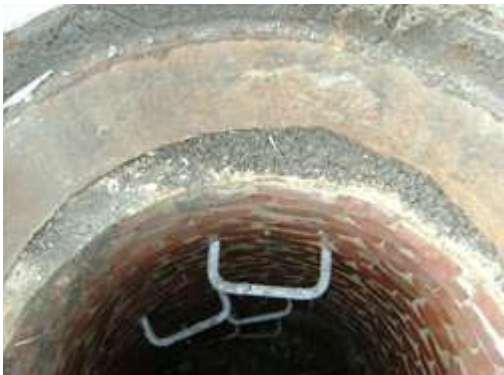
Defect 1

Frame Offset: **3** (in.) Condition: ☒ Sound ☐ Cracked ☐ Leaks

OFFSET FRAME

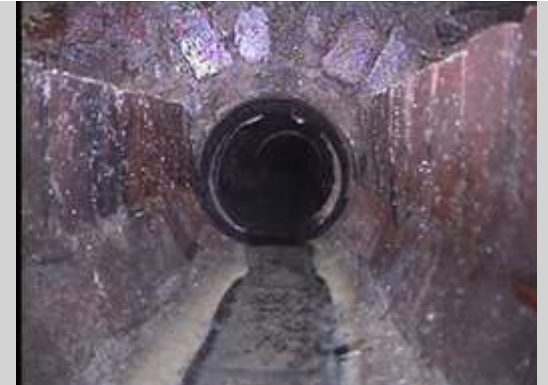
12 O'Clock Outflow

8 in. Circular Gravity Sewer
Pipe Out @ 12 O'Clock

Infiltration: **None** Pipe Seal Cond: **Sound**

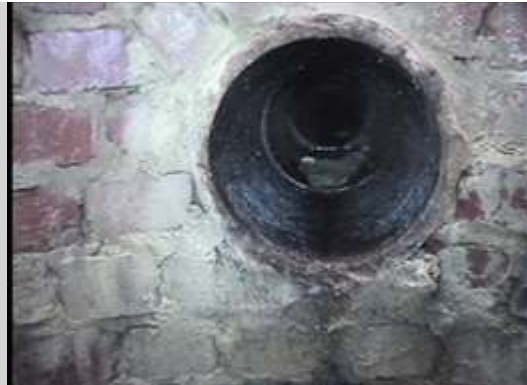
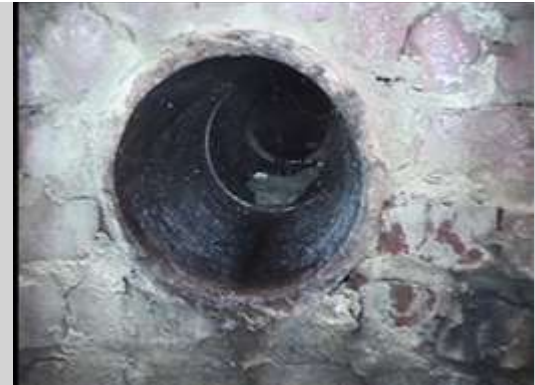
6 O'Clock Inflow

Pipe In @ 6 O'Clock

Infiltration: **None** Pipe Seal Cond: **Sound**

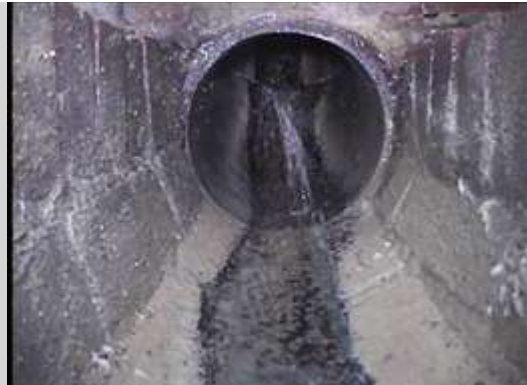
Drop In @ 6 O'Clock

Drop: **Outside** Rod and Bar

Drop Condition: **Open**
